We present to you an AS350B3 being in unserviceable condition after an incident during road transport.

A/C TT 10296 FH
Registration LN-OB
Serial number 3493

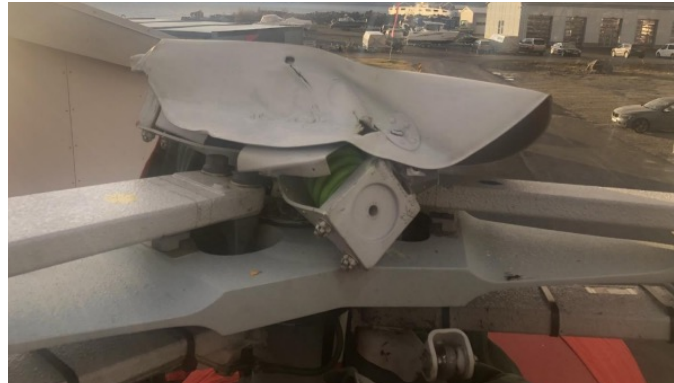
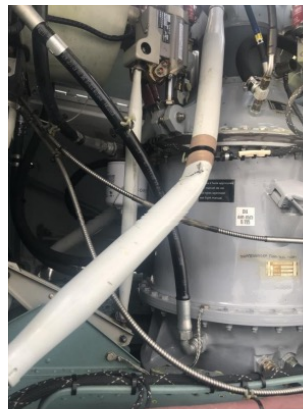
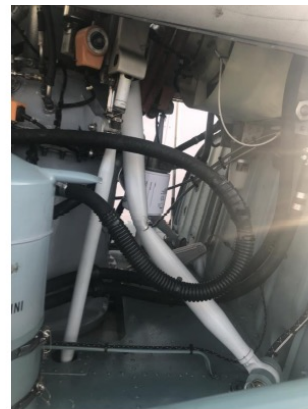
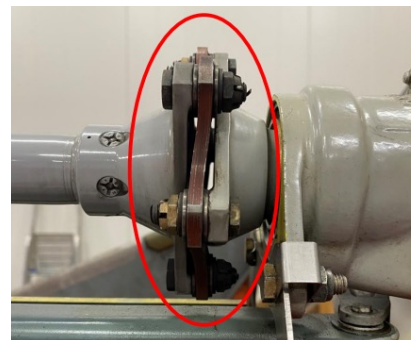
MRH, M/R Mast, MGB, Engine- to MGB driveshaft and associated components are unsalvageable and must be scrapped.
Engine is repairable.
